Manhole Inspection Summary

Manhole # S49Y1_008MH

Insp Date: **10/26/08 5:19 PM**

Location Address: **3315 Sun St.**

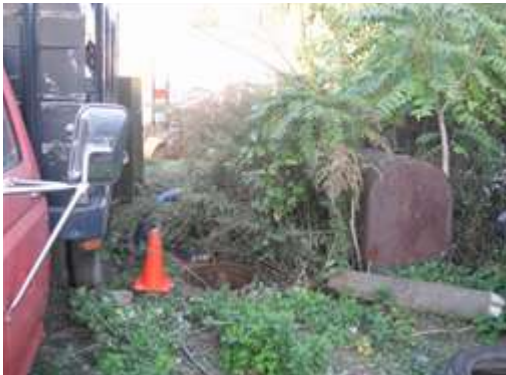
Location View

Comments **Manhole located in junk yard, view obscured by debris.**

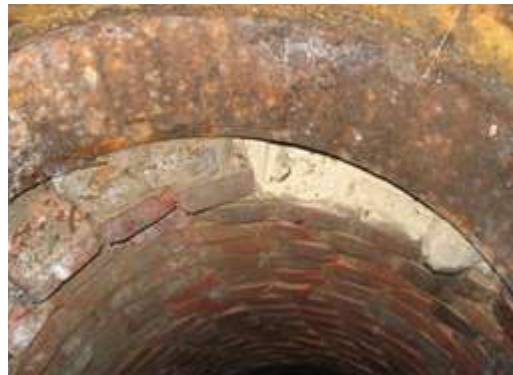
Defect 2

Chimney / Frame Adjustment ☒ Exists Material: **Brick** ☐ Parged Height: **4** (in.)

Condition: ☐ Sound ☐ Cracked ☐ Root Intrusion ☐ Loose Brick ☒ **Deteriorated**

Infiltration: ☐ None ☒ **Joint** ☐ Cracks ☐ Mortar ☐ Roots ☐ Wall

Deteriorated Chimney-Frame joint.

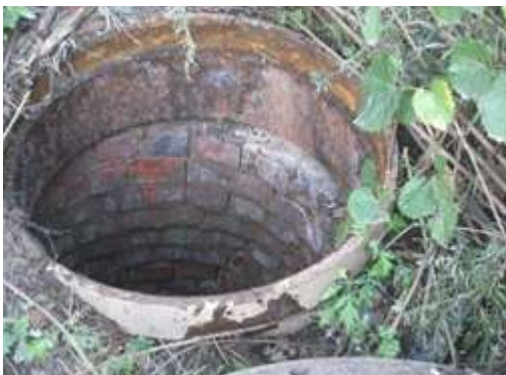
Defect 1

Frame Offset: **3** (in.) Condition: ☒ Sound ☐ Cracked ☐ Leaks

Frame offset

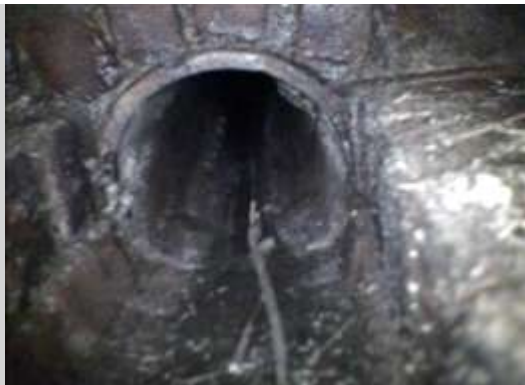
6 O'Clock Inflow

8 in. Circular Gravity Sewer
Pipe In @ 6 O'Clock

Pipe Height: **8.4** (in.) Rod and Bar (Angled)
Pipe Material: **Clay** ☐ Pipe Lined
Invert Depth: **9.80** (ft.) Flow Characteristics: **None**
Deposits: ☒ None ☐ Mud ☐ Sludge ☐ Debris ☐ Grease
Silt Depth: (in.) Deposits Extent:
Infiltration: **None** Pipe Seal Cond: **Cracked**
